East Birch Creek Aquatic Ecosystem Restoration Pilot Rock, Oregon

Environmental Assessment

**Authority: Section 206, 1996 Water Resources Development Act
Corps Project for Aquatic Ecosystem Restoration**

May 2001

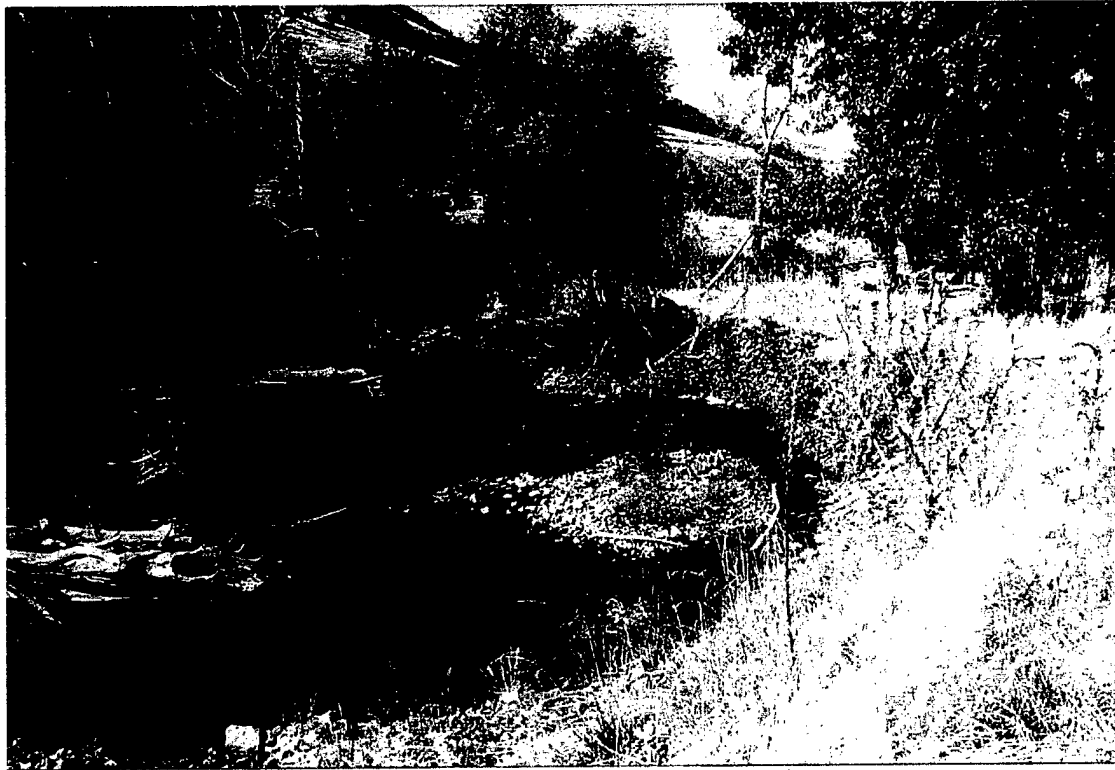
Photo 1 - 90-Degree Bends (Reach-1)

Reach-1 contains large gravel bars that move during high flows, head cutting, unstable banks and alignment problems (see Photograph 1), and lengths of channel where the thalweg is degraded. Most of Reach-1 has shrubs and trees lining the banks and most of the reach is shaded by canopy (see Photograph 2). In the last part of Reach-1, the tree and other vegetation roots have protected the banks from excessive erosion, unlike the first part of the reach. Also, the second part of Reach-1 is relatively straight and narrow (the bankfull width is only 25 ft (8 m) in this area) and the velocities associated with the reduced cross section and straight channel have effectively transported any sediment on through this area. This transport of sediment has possibly allowed the vegetation to remain in tact while other portions of the project have problems with large bars and erosion of the banks. While this area does not have aggrading problems, the streambed is down cutting, and the channel is more than 8 feet (2.5 m) deep. Other

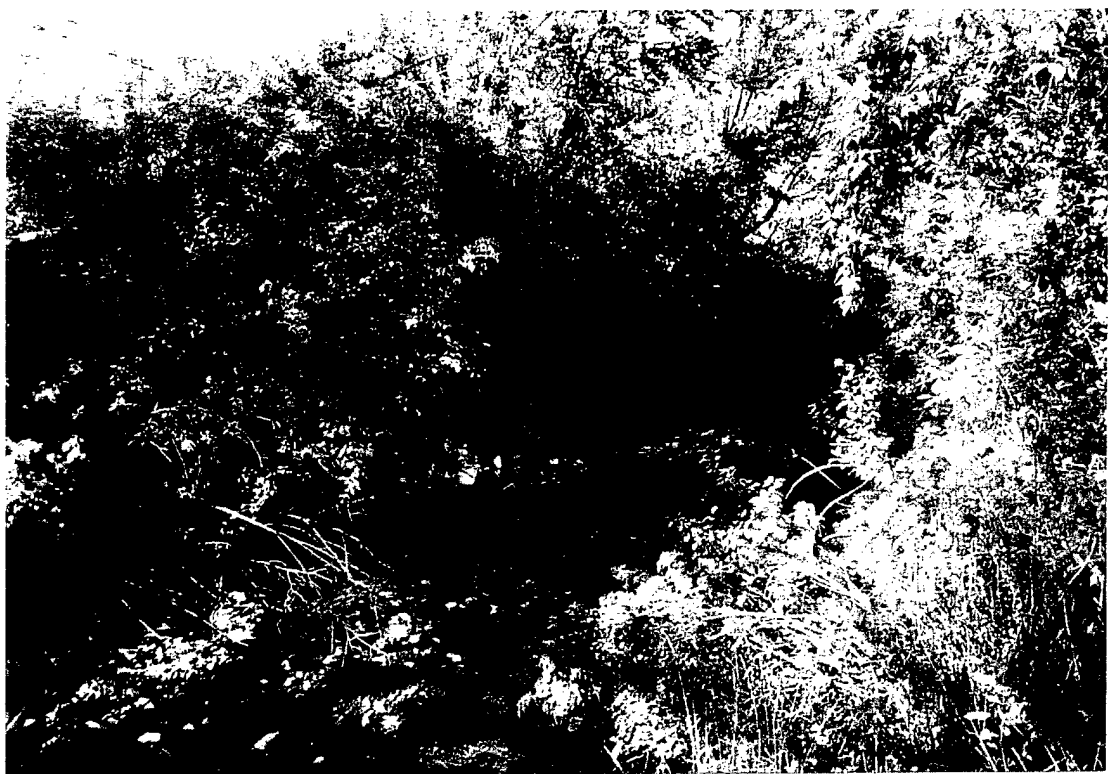
Photo 2 - Vegetation Intact with Downcut Streambed (Reach-1)

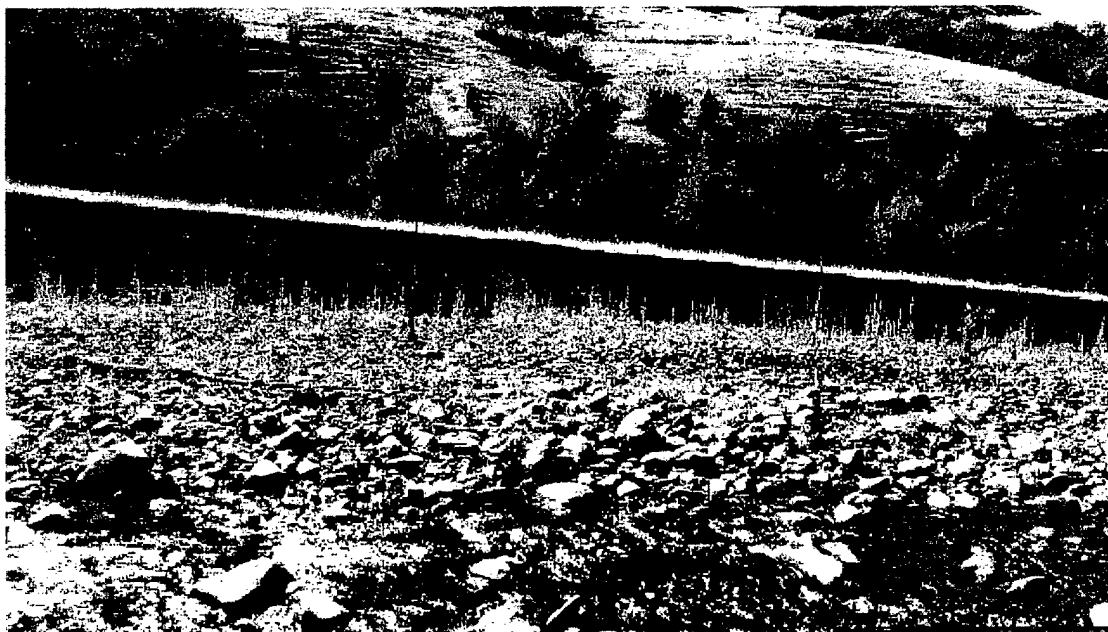
Photo 3 - Large Bars (Reach-2)

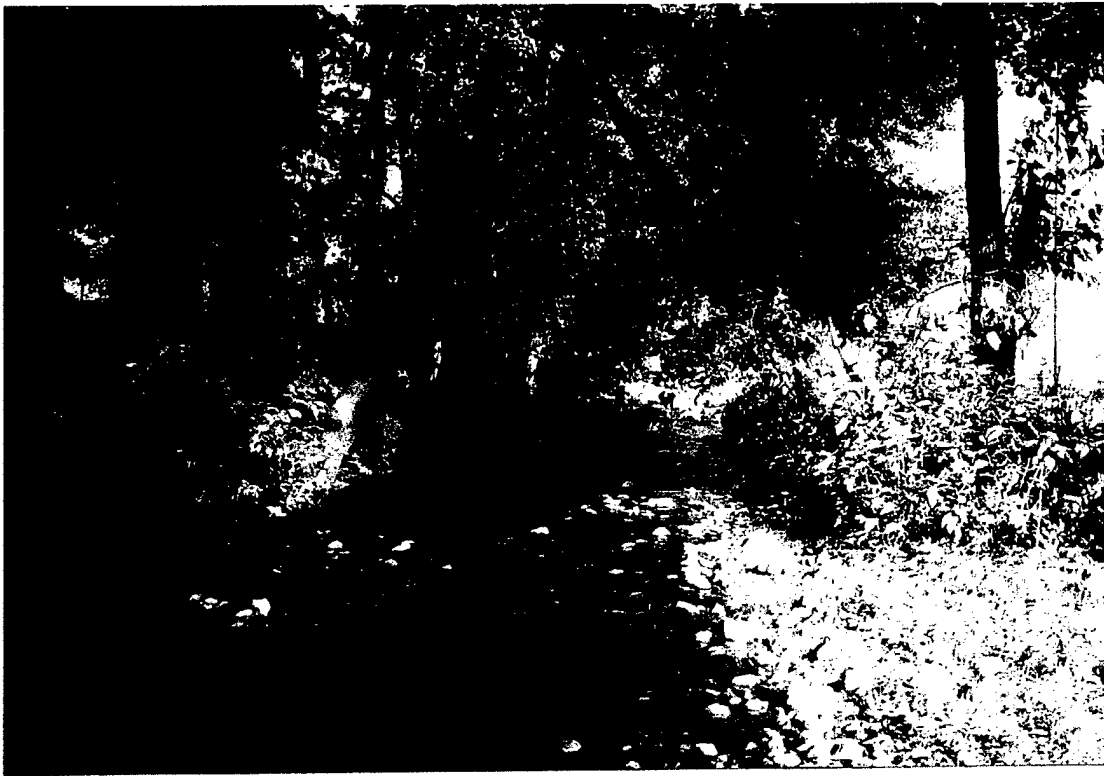
Photo 4 – Stable Transport of Sediment Load (Reach-3)

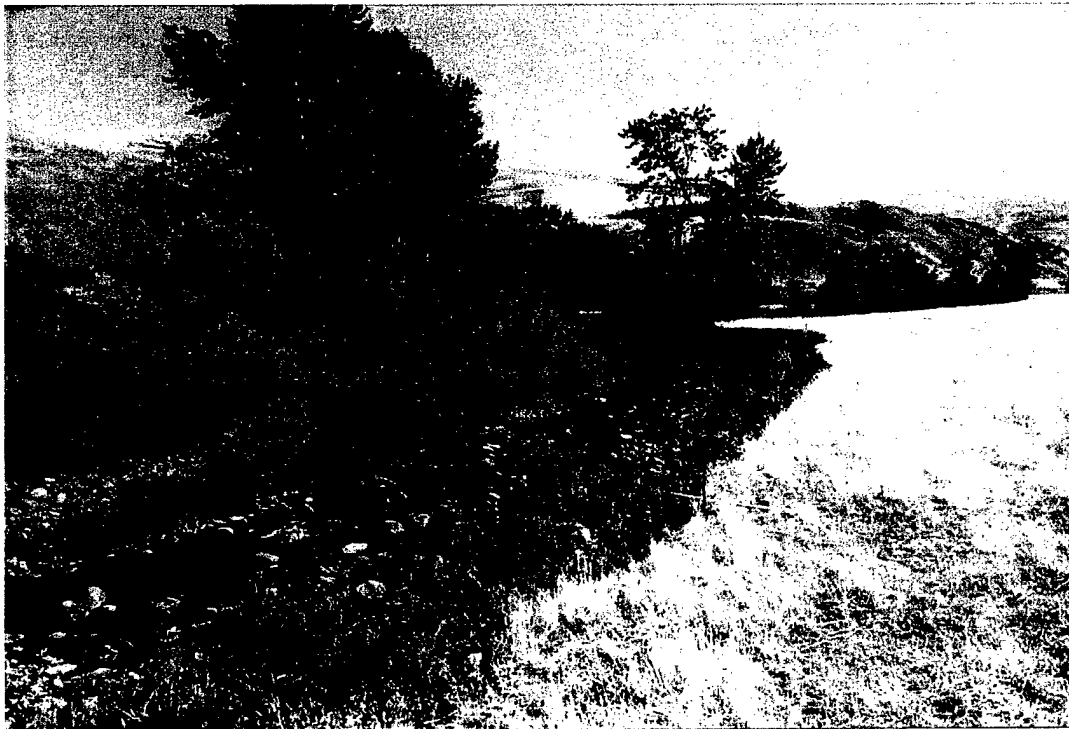
Photo 5 - Vegetation Reestablished and Streambed Armoring (Reach-5)

Reach-5 contains the final approximate 500 feet (150 meters) of the project. Reach-5 varies between type B and type C cross section geometry. This portion of the streambed is 7-8 feet (2 meters) below the ancestral floodplain. The stream meander pattern/sinuosity is altered by the ranching and agricultural uses and has a pattern typical of type B streams (straightened rather than meandering) but, would be a class C stream in undisturbed situations (indicated by valley type, valley slope, etc.). Much of this reach is approaching a stable condition. The boulders and cobbles are beginning to form an armor layer over the thalweg and vegetation is covering/stabilizing the bars (see Photograph 5).

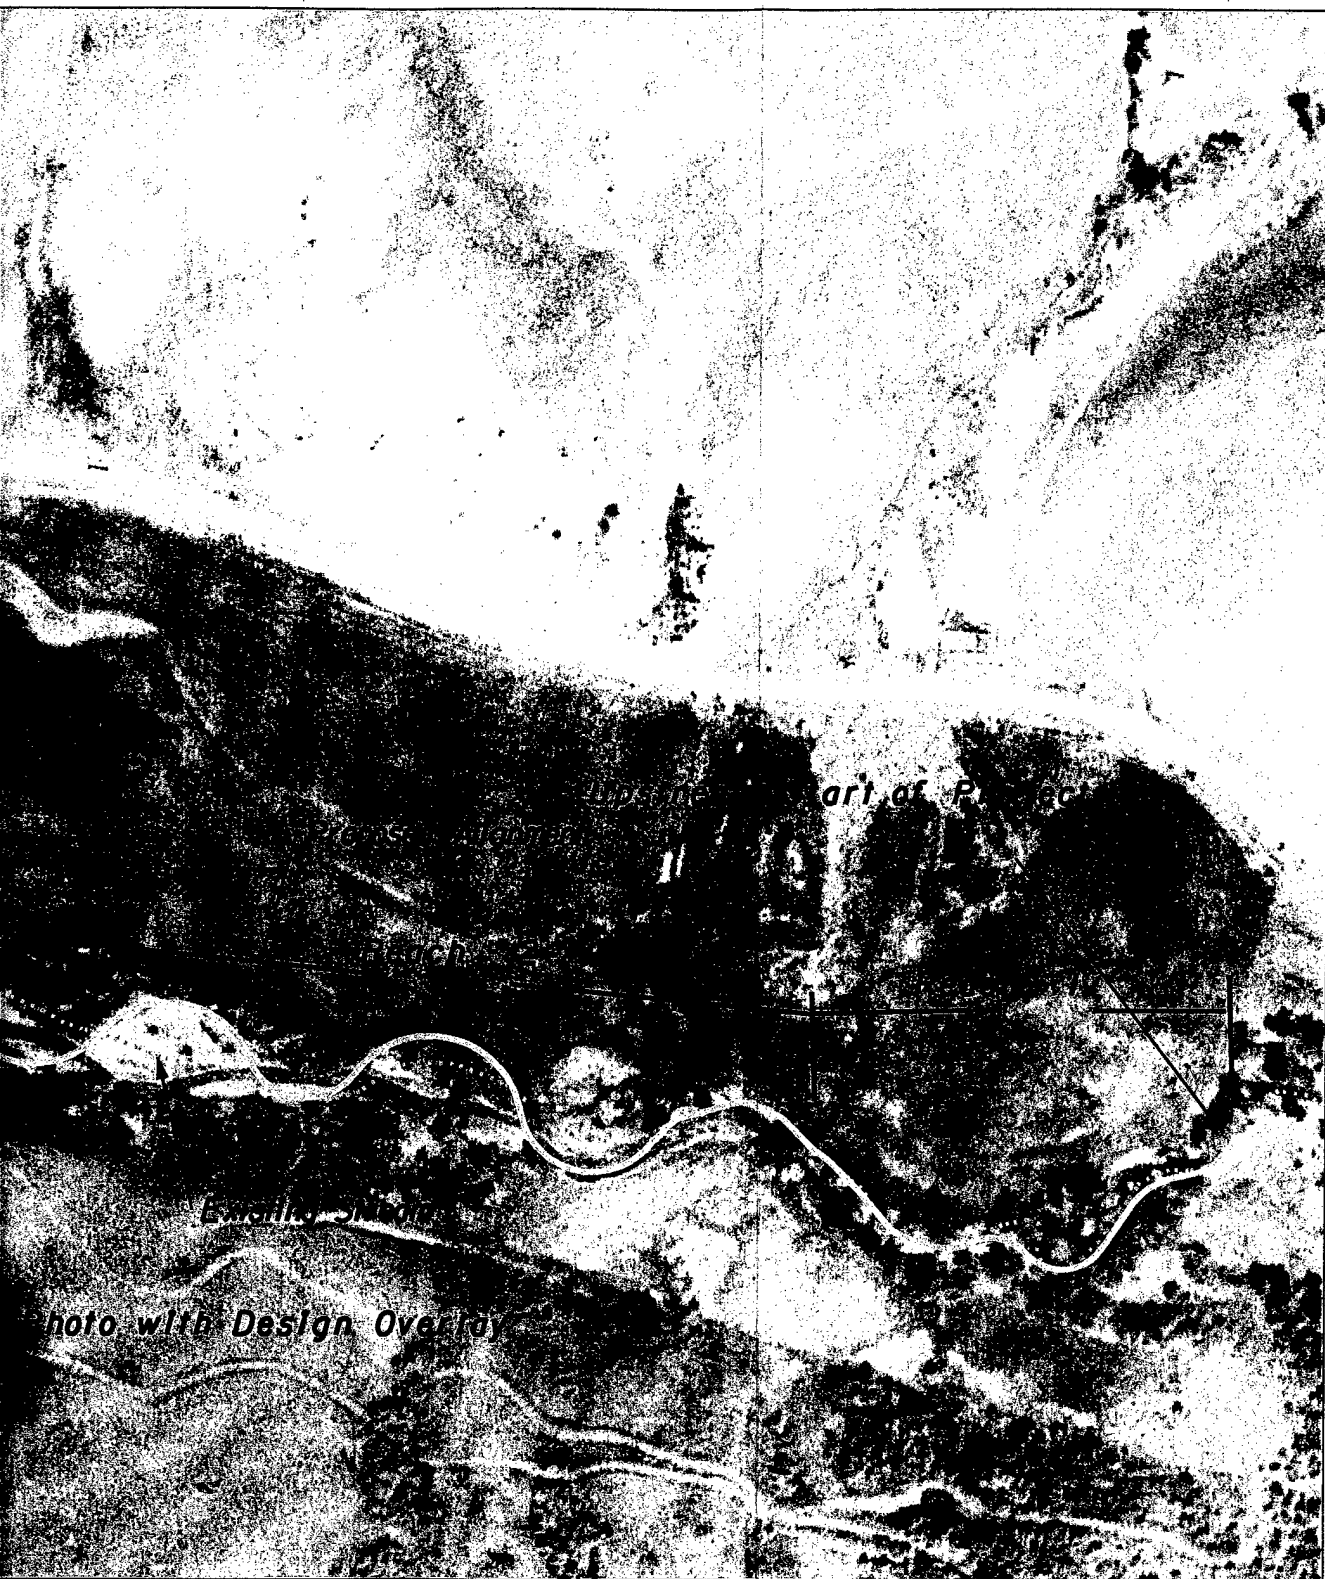
Upper part of Project

Photo with Design Overlay

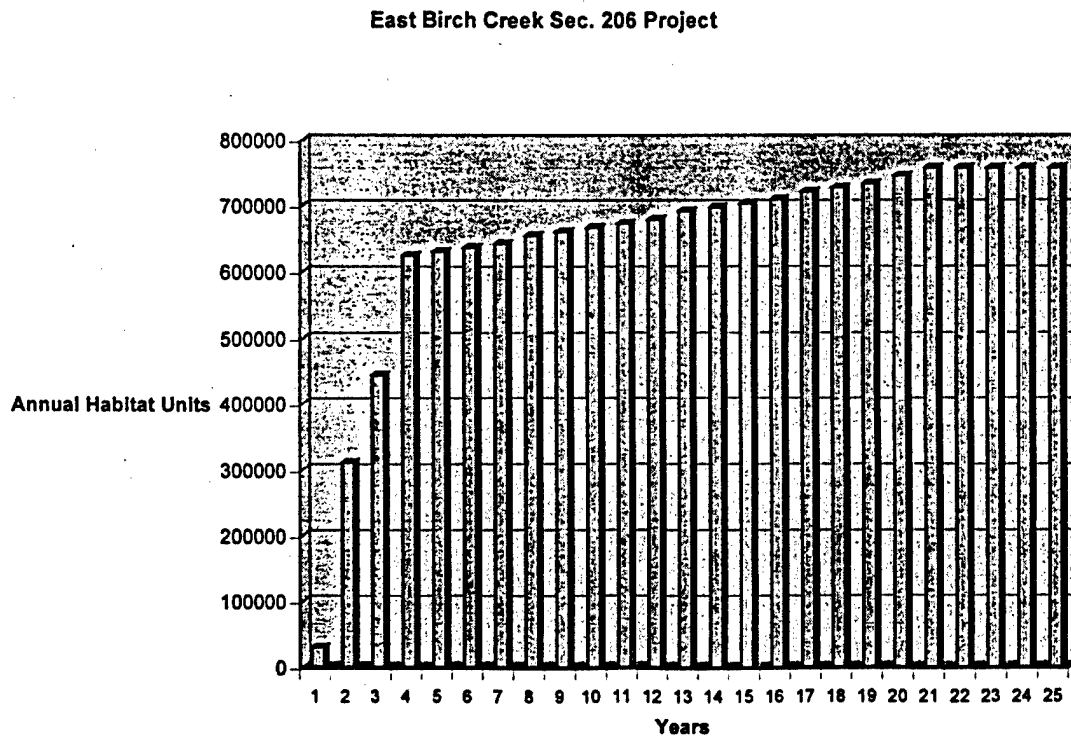
Figure 1. Annual habitat units created by the East Birch Creek 206 Project

It is anticipated that the East Birch Creek Project would have a rapid and profound effect on spawning and rearing habitat for ESA listed summer steelhead trout. Although it is difficult to relate actual summer steelhead production to habitat units as defined in this study, it is assumed that changes in key attributes judged to be limiting factors for steelhead are an appropriate predictor of production. Figure 1 shows the change in habitat units, which are an index of habitat quality, expected to occur in the 25 years following construction of the project. The existing, pre-project condition was determined to have an aggregate value of 30,500 habitat units, which relates to poor habitat conditions and poor production rates for summer steelhead. By year three, assuming normal runoff cycles, the aggregate habitat value would be up to 625,180 habitat units which indicates excellent habitat conditions and relates to much higher production rates for naturally spawned summer steelhead. After year three the increase in habitat quality is more gradual through year 21 when the quantity of habitat units levels off through year 25. This amounts to a 20-fold increase in the ability of habitat to meet the life requirements of a species that is listed as Threatened under the ESA. In the 25-year life of the East Birch Creek Project, 648 thousand average annual habitat units will have been created.
